Maryland Historical Trust State Historic Sites Inventory Form

WA-III-095 Frame House 18952 Sandy Hook Road (MD 180), Sandy Hook Harpers Ferry Quadrangle

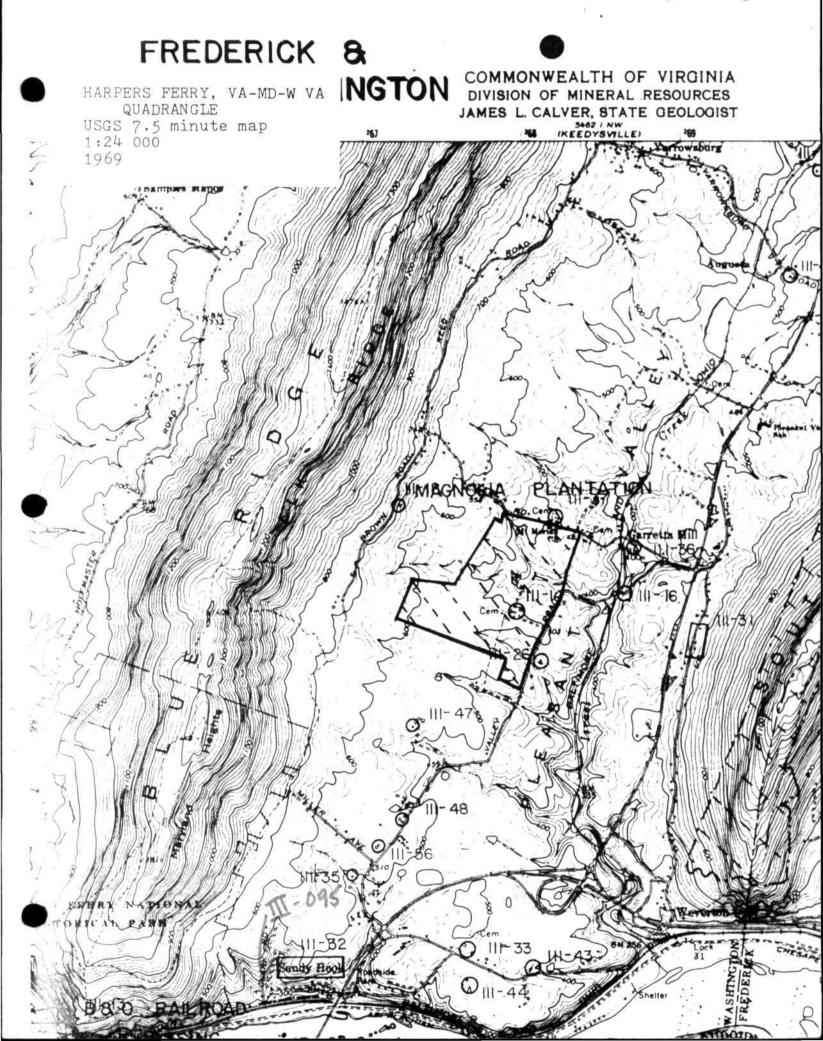
- WA-III-095
- Washington Co., Md.
- Joe Getty
- April 1983 7/82
- Md. Hist. Trust, Annapolis, Md.
- South elev. (camera facing north)
- 1/1

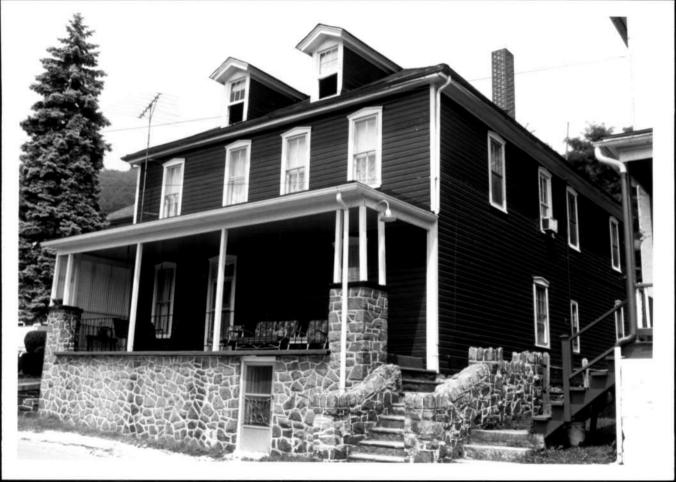
The frame house is a two and one-half story frame structure constructed in a square shaped plan. It is built into a slope on a high fieldstone foundation with a full story on the main facade. The main facade has early-20th century stone work facing on the foundation level that includes corner plinths and side stairs. The square shape of the house and the hipped roof give it a Four-square style appearance although other features in the structure are late Victorian style. The structure is four-bays by four-bays and covered in German siding. It has two gable-roof dormers on the main facade. Windows have plain trim with a pointed-arch cornice. The structure appears to date from the late 19th century.

The two and one-half story structure is constructed of frame covered in German siding on a stone foundation. The main facade is asymmetrically arranged. It has a full-story at the foundation level with a single entrance. The foundation is covered in a random ashler pattern. This stonework also forms corner plinths near the front porch and a stairway on the east facade of the structure. The main story of the structure has an entrance in the second bay from the west. The third bay from the west has no opening and the outer bays have two-over-two sash windows. These windows have plain trim with a pointed-arch cornice. Similar trim along with a two-pane transom and round-arch upper panes are in the door. Two-over-two sash windows, several with round-arch upper panes are located in the four bays of the second story and in the bays on the sides of the house. The gable dormers have molded gables with six-over-one windows. The hipped roof is covered in sheet metal. An interior-end brick flue rises from the east side of the roof.
